PROGRESS REPORT

SnagClear Report

| PROPERTY ADDRESS Snagclear Avenue, SN8 8AG | | INSPECTION DATE 16 Apr 2026 | |

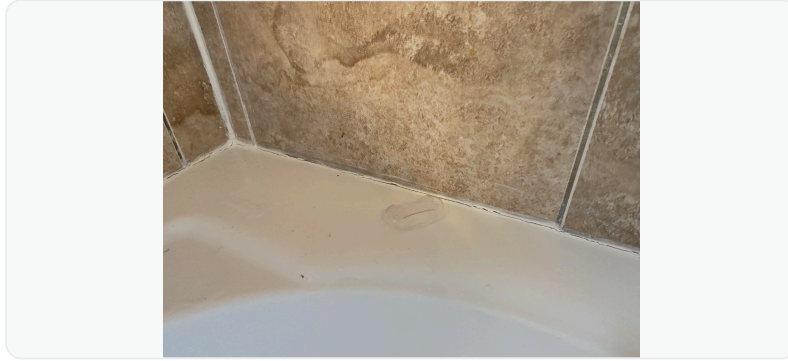
S001 In Progress

| Ref | Room | Category | Description | Added | Status |
|---|---|---|---|---|---|
| S001 | Bathroom 1 | Sealants / silicone | Silicone sealant around the shower tray is uneven. | 16 Apr 2026 | In Progress |

Silicone sealant around the shower tray is uneven.

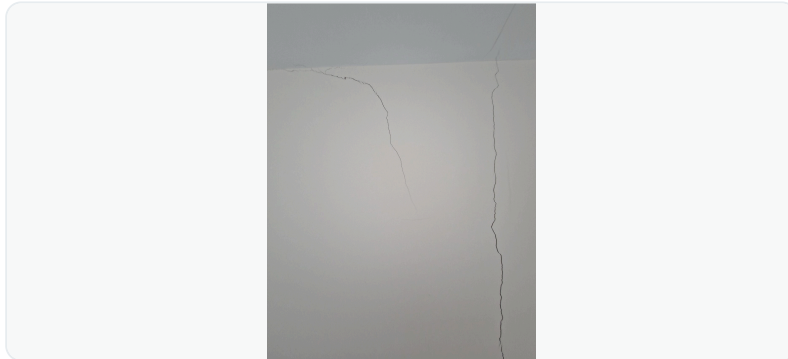
S002 In Progress

| Ref | Room | Category | Description | Added | Status |
|---|---|---|---|---|---|
| S002 | Bedroom 1 | Walls (plaster/paint) | The wall next to the door has visible cracking in the plaster. | 16 Apr 2026 | In Progress |

The wall next to the door has visible cracking in the plaster.

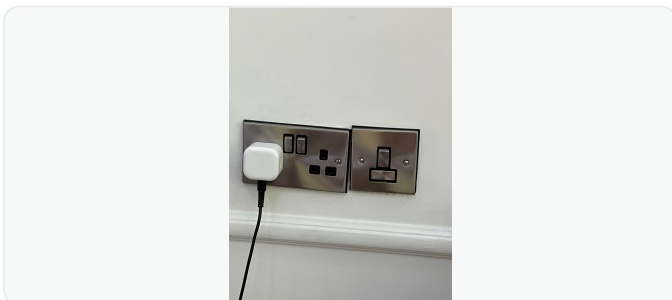
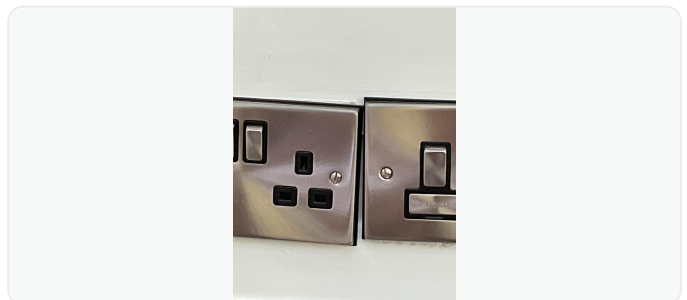
S003 Open

| Ref | Room | Category | Description | Added | Status |
|---|---|---|---|---|---|
| S003 | Bedroom 1 | Electrics (sockets/lighting) | Socket faceplate is crooked and not securely fixed. | 16 Apr 2026 | Open |

Socket faceplate is crooked and not securely fixed.

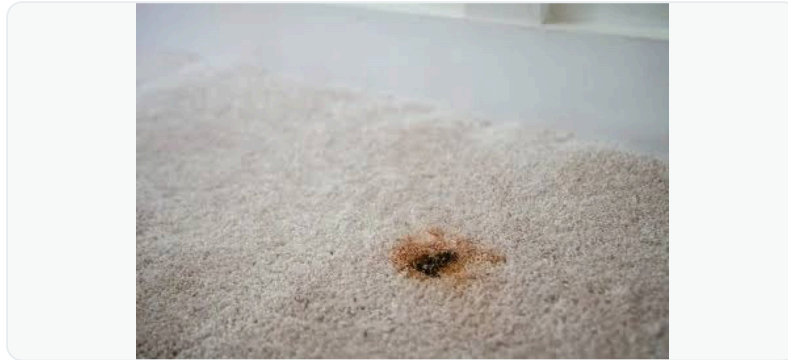
S004 In Progress

| Ref | Room | Category | Description | Added | Status |
|---|---|---|---|---|---|
| S004 | Bedroom 2 | Floors / carpet | There is visible damage to the carpet in Bedroom 2. | 16 Apr 2026 | In Progress |

There is visible damage to the carpet in Bedroom 2.

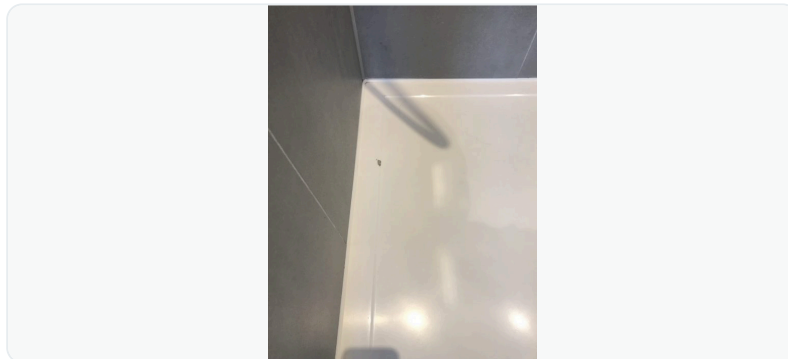
S005 Open

| Ref | Room | Category | Description | Added | Status |
|---|---|---|---|---|---|
| S005 | Ensuite 1 | Sealants / silicone | Silicone sealant to shower tray is applied unevenly and looks rough. | 16 Apr 2026 | Open |

Silicone sealant to shower tray is applied unevenly and looks rough.

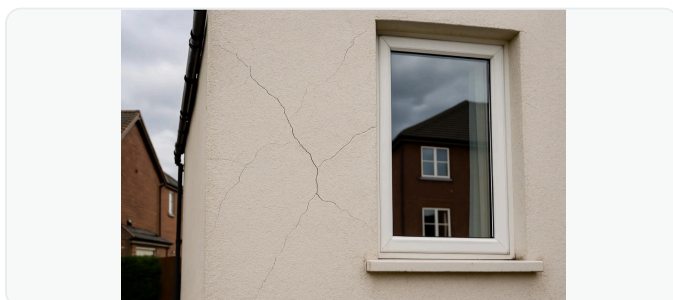
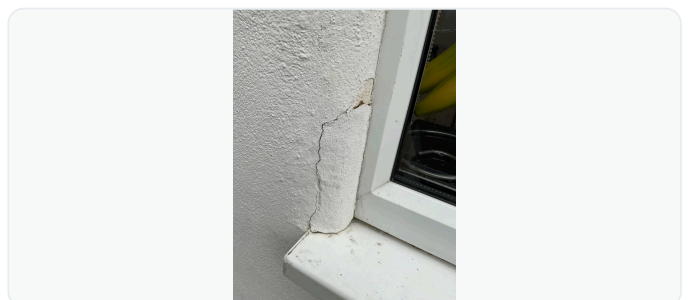
S006 Resolved

| Ref | Room | Category | Description | Added | Status |
|---|---|---|---|---|---|
| S006 | Exterior | External walls (brick/render) | There is a crack in the render on the external wall approximately the thickness of a credit card. | 16 Apr 2026 | Resolved |

There is a crack in the render on the external wall approximately the thickness of a credit card.

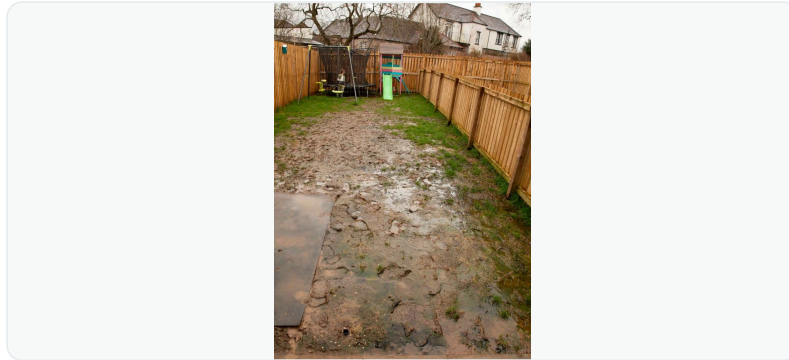
S007 Resolved

| Ref | Room | Category | Description | Added | Status |
|---|---|---|---|---|---|
| S007 | Exterior | Garden / landscaping | Water is pooling in the garden, causing waterlogging. | 16 Apr 2026 | Resolved |

Water is pooling in the garden, causing waterlogging.

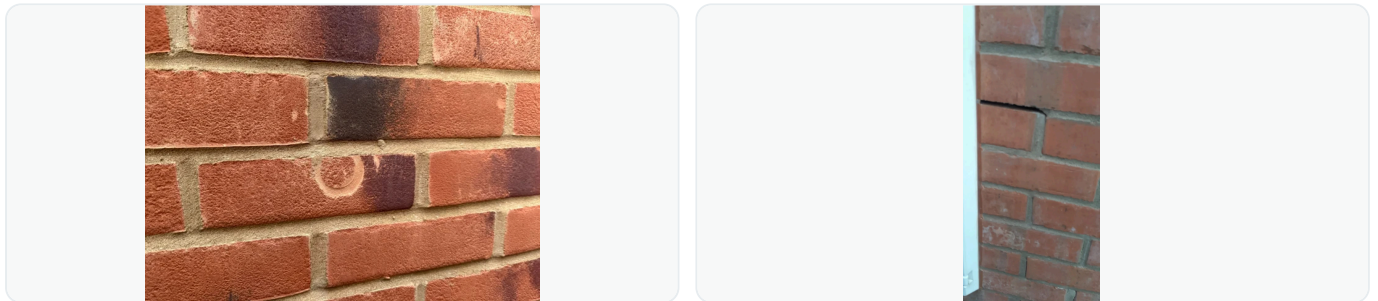
S008 In Progress

| Ref | Room | Category | Description | Added | Status |
|---|---|---|---|---|---|
| S008 | Exterior | External walls (brick/render) | Damage to brickwork next to kitchen window | 16 Apr 2026 | In Progress |

Damage to brickwork next to kitchen window

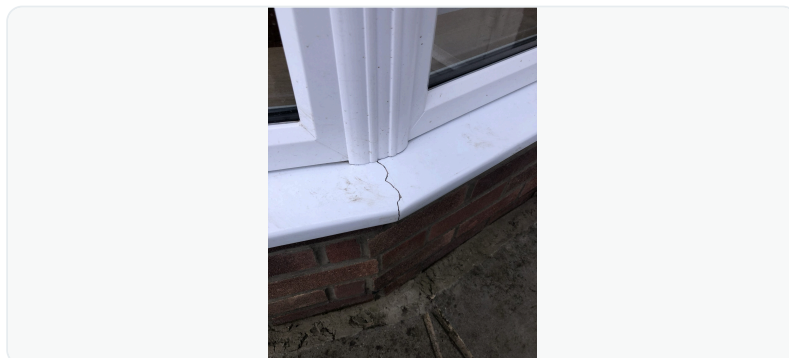
S009 Open

| Ref | Room | Category | Description | Added | Status |
|---|---|---|---|---|---|
| S009 | Exterior | Windows | There is a crack in the window sill about a credit card thick. | 16 Apr 2026 | Open |

There is a crack in the window sill about a credit card thick.

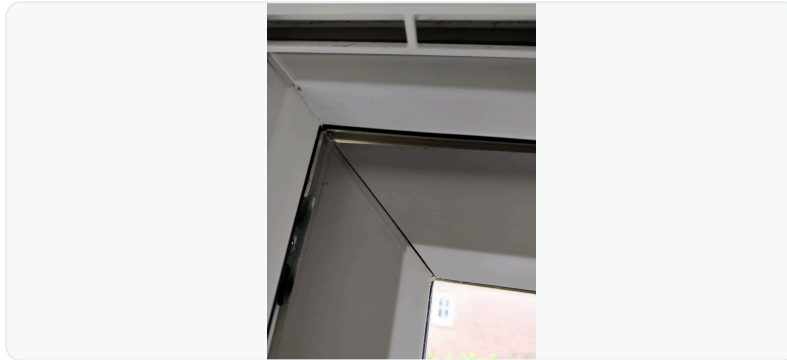
S010 Resolved

| Ref | Room | Category | Description | Added | Status |
|---|---|---|---|---|---|
| S010 | Exterior | External doors | The front door does not fit tightly, leaving a visible gap. | 16 Apr 2026 | Resolved |

The front door does not fit tightly, leaving a visible gap.

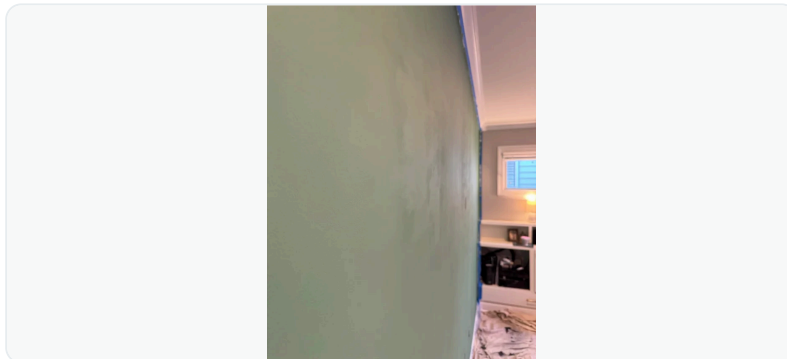
S011 Open

| Ref | Room | Category | Description | Added | Status |
|---|---|---|---|---|---|
| S011 | Hallway / Landing | Walls (plaster/paint) | The wall opposite the door has an uneven paint finish. | 16 Apr 2026 | Open |

The wall opposite the door has an uneven paint finish.

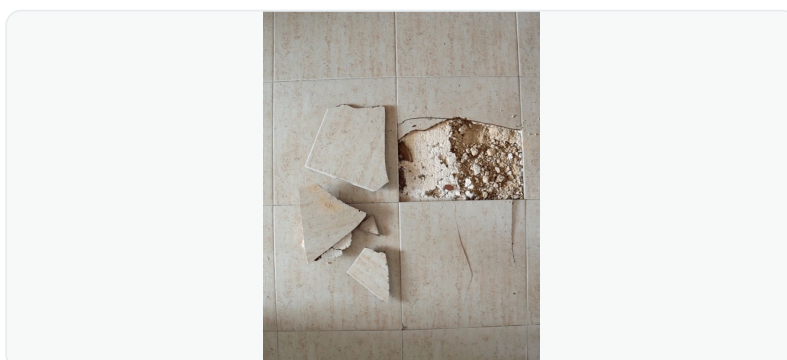
S012 In Progress

| Ref | Room | Category | Description | Added | Status |
|---|---|---|---|---|---|
| S012 | Kitchen | Floor finish | Floor tiles are cracked and damaged. | 16 Apr 2026 | In Progress |

Floor tiles are cracked and damaged.

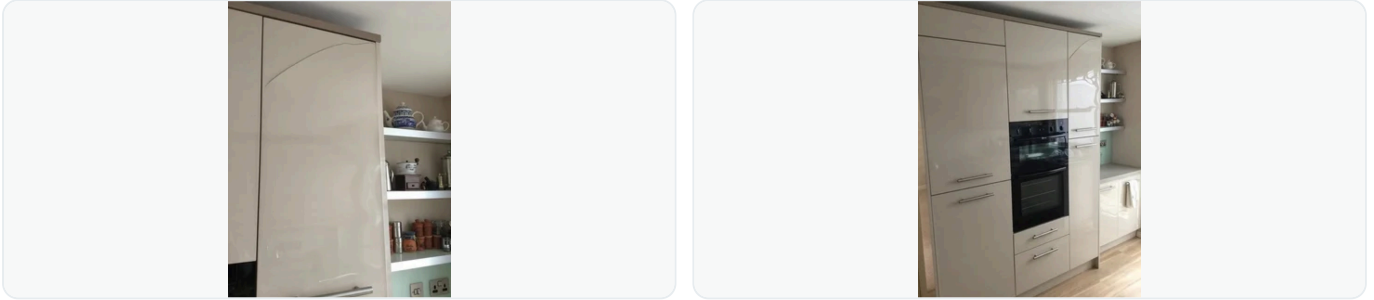
S013 [Open](#)

| Ref | Room | Category | Description | Added | Status |
|---|---|---|---|---|---|
| S013 | Kitchen | Units / cupboards | Crack approximately the thickness of a credit card is visible on the fridge cupboard door. | 16 Apr 2026 | Open |

Crack approximately the thickness of a credit card is visible on the fridge cupboard door.

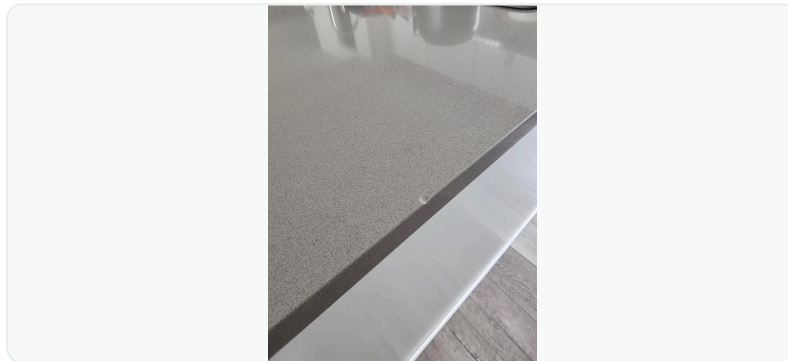
S014 [Open](#)

| Ref | Room | Category | Description | Added | Status |
|---|---|---|---|---|---|
| S014 | Kitchen | Worktops | A section of the kitchen worktop is chipped. | 16 Apr 2026 | Open |

A section of the kitchen worktop is chipped.

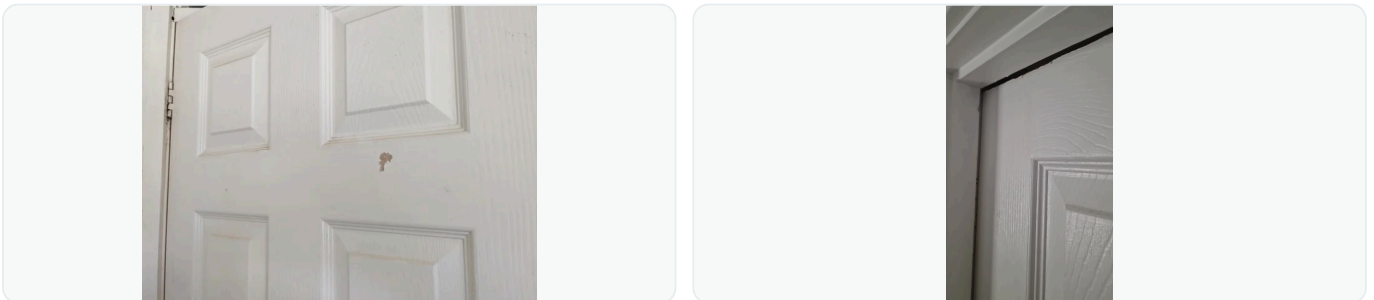
S015 [Open](#)

| Ref | Room | Category | Description | Added | Status |
|---|---|---|---|---|---|
| S015 | Kitchen | Doors | The kitchen door shows signs of damage. | 16 Apr 2026 | Open |

The kitchen door shows signs of damage.

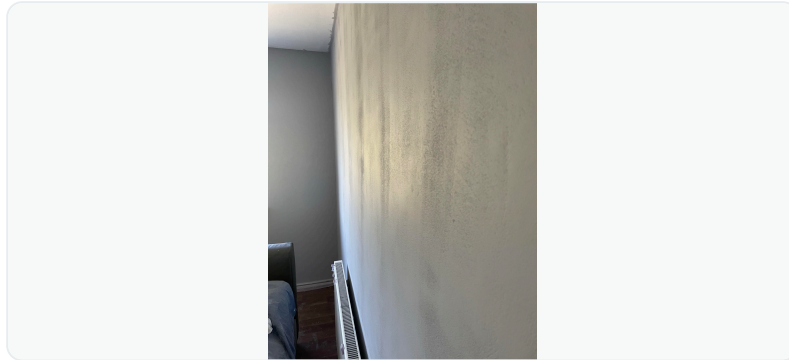
S016 In Progress

| Ref | Room | Category | Description | Added | Status |
|---|---|---|---|---|---|
| S016 | Living room 1 | Walls (plaster/paint) | Wall surface shows an uneven and coarse paint finish. | 16 Apr 2026 | In Progress |

Wall surface shows an uneven and coarse paint finish.
